# BOULDER COUNTRY CLUB

Boulder, Colorado

## Swimming Pool Audit

November 2020

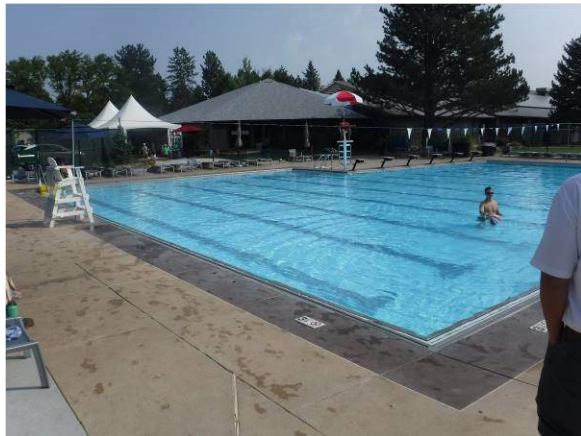
The sealant at the expansion joint of the pool is in fair condition.

Provide leak detection testing services at the lap pool vessel and the gutter vessel individually. Provide ground penetrating radar testing, Schmidt hammer testing, and core samples in order to determine the condition of the concrete structure. Refer to Appendix A for recommendations regarding leak detection testing and structural testing. Identify any areas where water loss is occurring and repair.

Replace the aging liner at the lap pool.

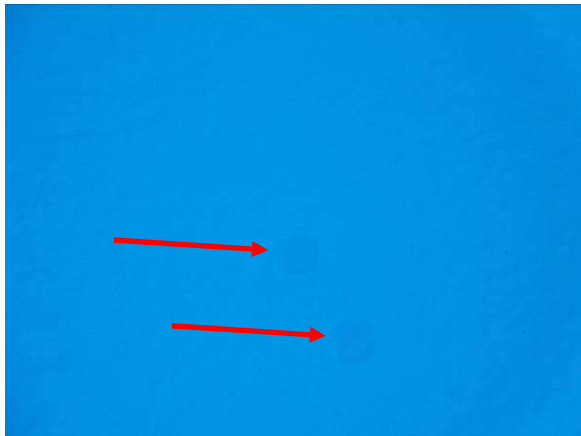
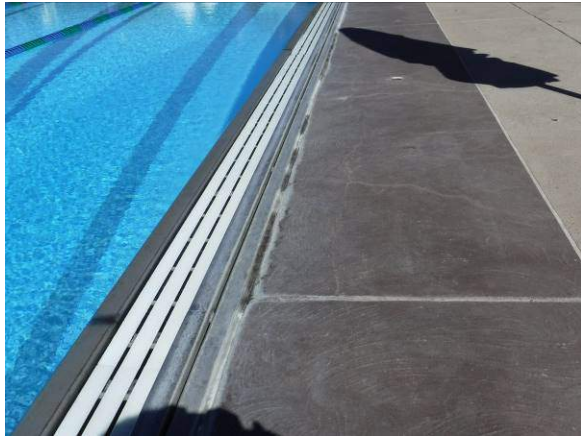
Staff has reported that the wading pool concrete structure has been cracking, and the perimeter wall of the pool had crumbled.

A new Renosys PVC liner was installed in the past 2 years and is in good condition. It has not been confirmed whether the wading pool is still experiencing water loss after this installation.

The sealant at the expansion joint of the pool is in fair condition in most locations.

**In lieu of (or in addition to) all the repairs above, replace the outdoor lap pool and outdoor wading pool structures at the facility. Construct each vessel in accordance American Concrete Institute (ACI) 350 standards to ensure water tightness prior to the application of any pool finishes. Provide a proprietary quartz aggregate finish at all the pools.**

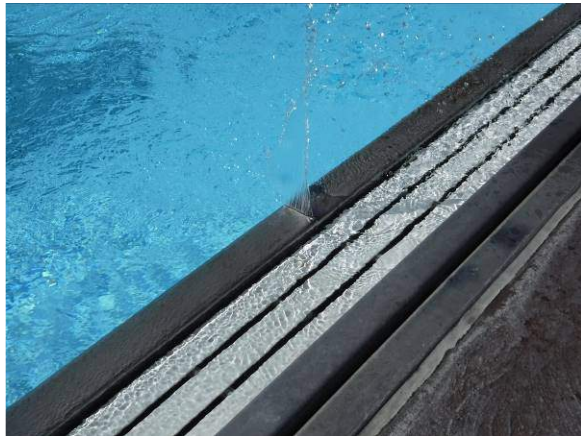
A stainless steel, rollout-style overflow gutter was added to the lap pool in 2003. The gutter has an integrated pressure tube for water return to the pool, and an integrated perimeter deck drain feature at the interface between the pool and the deck. The stainless-steel gutter is in poor condition and it is compromised structurally.

During the C-H audit visit to site, there were 3 areas where filtered water was spurting from the pressure tube system. These compromises are obvious; this leads us to believe there may be several other unseen areas that may be causing water loss from the pool to either the integrated deck drainage systems, or the soils surrounding the pool vessel.

Weld and repair the compromised areas of the stainless steel gutter pressure tube system.

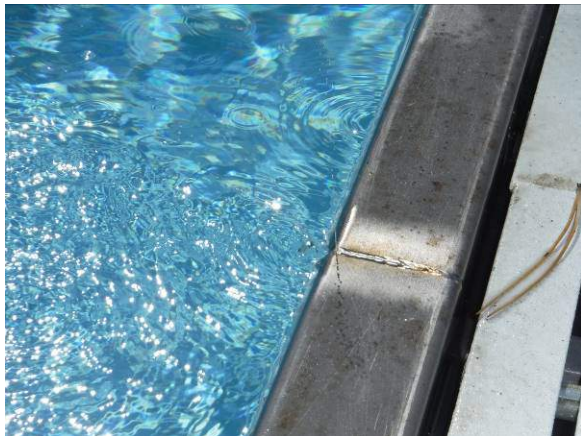
Staff indicated that the gutter is not level. This was also visually seen during the site visit: when splashing was not occurring, some areas of the overflow gutter lip were below the water line while other sections were dry to the touch. A level gutter is required by MAHC (tolerance of +/- 1/16") and Colorado Pool Code (level within 3/10") in order to provide consistent surface skimming for all areas of the pool.

During the initial Boulder CC visit prior to the audit, the standard operating water level was higher than the overflow lip in all sections of the pool. This entirely negates the surface skimming effect of the system required by administrative code for operating a pool.

In conjunction with a pool replacement, replace the perimeter overflow system in its entirety at both pools.

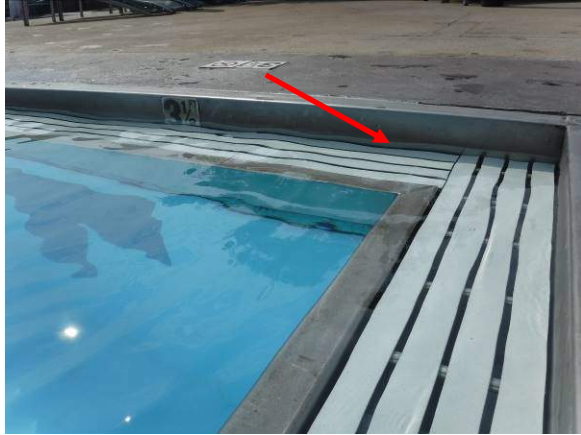
Fiberglass gutter grating appeared to be properly fastened and in fair condition; staff reports that this grating was replaced in 2018.

A surge tank was observed for the lap pool in the space between the mechanical room and the deep end. However, it is not in operation, and float valves are not present. A surge tank is crucial to making sure water level stays consistent in a gutter pool when bathers enter or exit.

In conjunction with a pool replacement, provide a surge tank and float valves for any pool system that is utilizing a perimeter overflow gutter rather than skimmers.

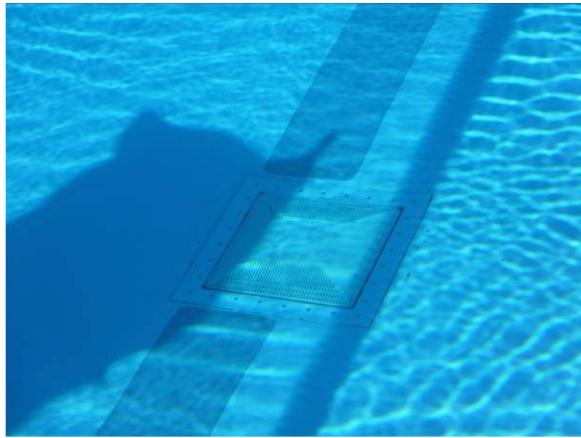
The grates are rated for a maximum flow of 816 gpm, which is greater than the 722 gpm flow rate of the pool. The grates in this pool were last replaced in October of 2018, which indicates these grates are not expired.

At the time of the visit, it could not be confirmed that the hydrostatic relief valves located within the sumps are operational – staff to confirm.

Confirm that existing hydrostatic relief valves are in-place and operational.

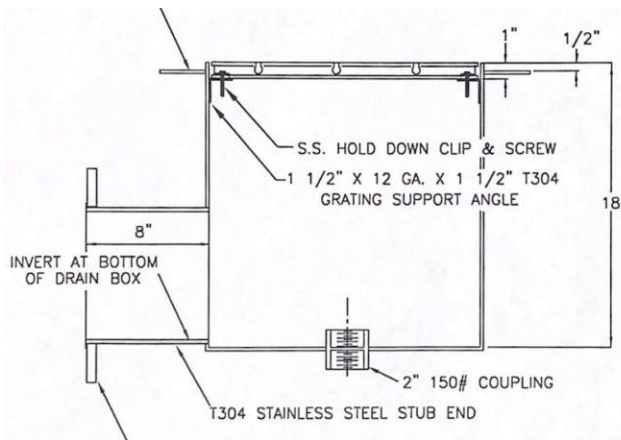
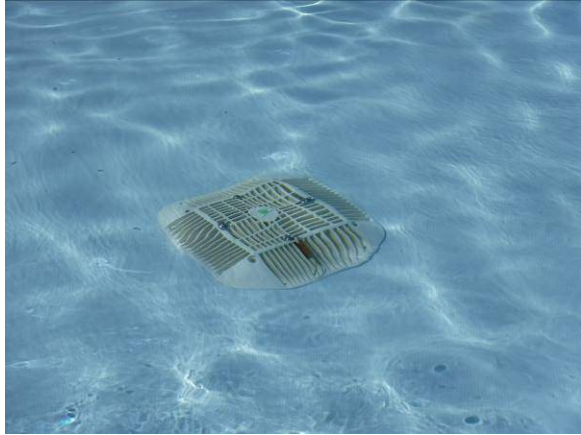
There are three (3) wading pool suction outlets: two (2) are located within the pool floor, and one (1) is located within the wing wall of the pool.

The pool floor drains are Aquastar Grates, model 914xxx. They were recently replaced in 2019 and do not expire anytime soon. With an overall flow rate of approximately 108gpm in the pool, these grates are acceptable.

The suction outlet located within the wing wall is an abnormally sized metallic grating. This outlet is not considered VGB compliant. However, since two (2) other suction outlets exist in each individual pool area, the pool would still be considered VGB compliant if this wing wall outlet was removed.

**In conjunction with a major pool replacement, provide prefabricated sumps and piping outlets that are certified as VGB compliant.**

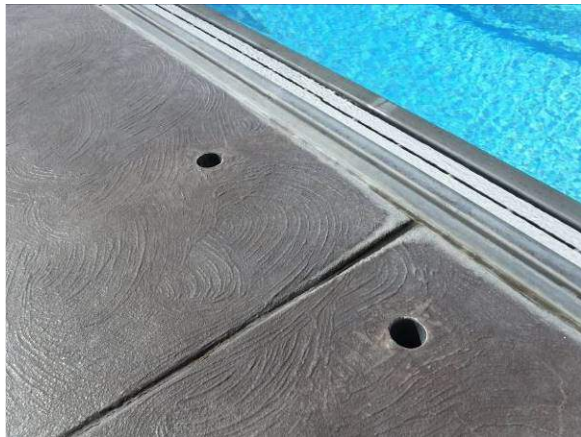
Stainless steel removable ladders were observed in a storage area adjacent to the pool deck, and they appear to be in good/fair condition. Wedge anchors for ladders are installed in the deck and appear to be in fair condition. However, some anchors were missing tightening hardware, or hardware adjustment is prevented by the deck finish. Stanchions for backstroke flags are present, and appear to be in good condition.

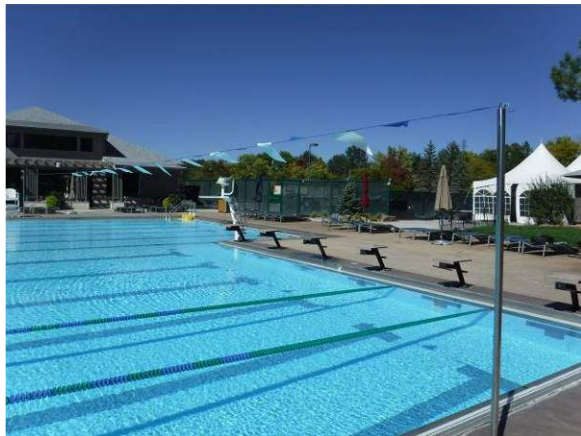
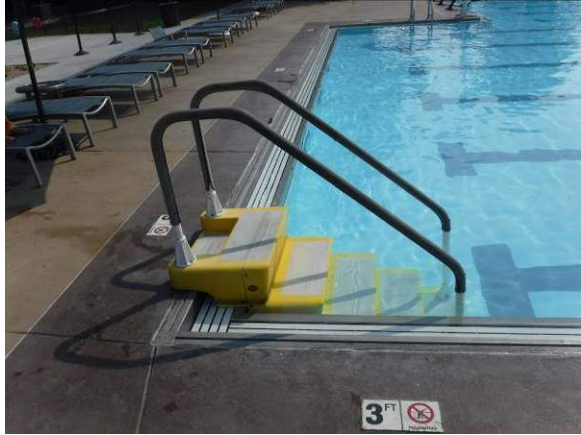
Since the pool perimeter is in excess of 300 lineal feet, two (2) means of ADA access are required: a primary and a secondary. The removable stair entry installed at the shallow end of the lap pool appears to be in good condition. While this stair entry can be counted as a secondary means of ADA Access to the pool, it is not considered a primary. A primary means of ADA access entails a ramp or an ADA lift.

According to staff, a guard rail used to be installed between the two (2) wading pool sections. Since then, the guard rail posts were cut down and capped to place a winterizing cover at the pool.

**In conjunction with a major replacement, construct a wading pool that includes a zero-depth entry for ADA compliance, and provide necessary ingress/egress as required by code at the lap pool.**

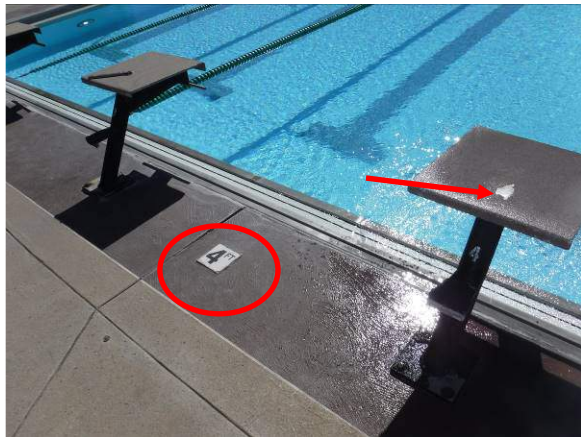
There are 6 starting blocks located at the lap pool. The platforms show their age and are in poor condition. The intermediate steps to the tops of the platforms are undersized, and the non-slip in those areas have delaminated completely. Non-slip surfaces on the tops have begun to delaminate. Some of the protective coating is beginning to flake off the frames.

Some of these platforms are located at water depths as shallow as 4'. While this is an acceptable water depth for competition, this depth is not suitable for teaching racing starts per USA Swimming.

Replace the starting platforms and backstroke flags.

**In conjunction with a pool replacement, locate the starting blocks in water depth of 6' -7" or greater in order to meet required depths for teaching racing starts.**

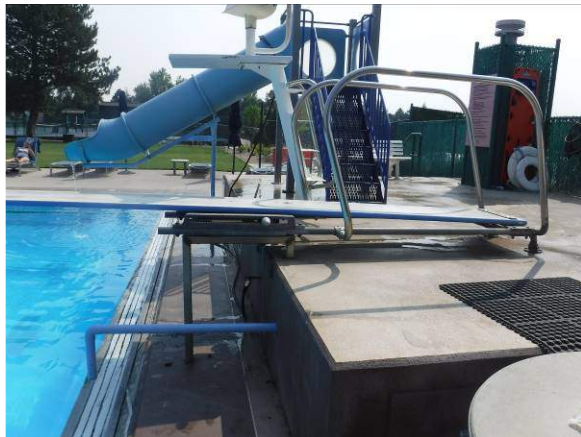
There is a diving board and a drop slide located in the deep end of the lap pool. The dive stand is custom fabricated and is in fair/poor condition. There are signs of staining, and portions of what appears to be a cast-in-place anchor are protruding through the slab face. The board itself appears to be an SR Smith board. Portions of the top are delaminating to a smooth surface, which can be a hazard to divers.

Dimensions were taken for the lap pool diving well, and the water depths do not meet minimums called for by administrative code. Refer to Appendix C for an illustration of the lap pool diving well sections.

**In conjunction with pool replacement, replace the dive stand with a commercial-grade dive stand and spring board (Duraflex) and replace the drop slide structure.**

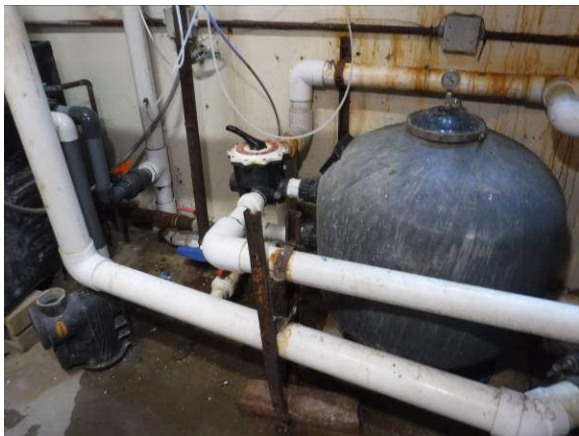
Supports for all the lap pool piping are in poor condition. Serious signs of corrosion are present, and the piping is not properly supported at appropriate intervals.

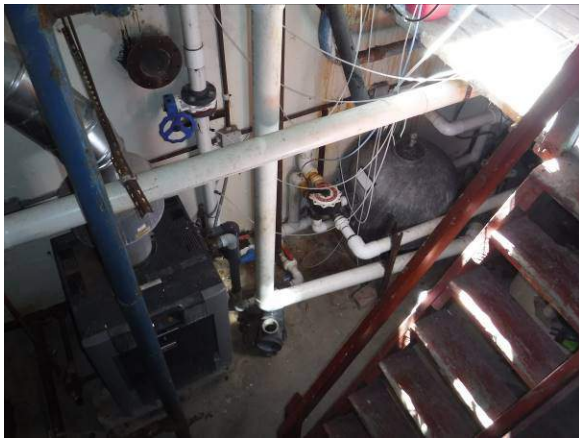
Piping is not labeled with directional arrows or color coding as required by administrative code. All piping for this system is sized correctly in accordance with code.

Provide tags for all valves in accordance with MAHC. In conjunction with a major pool replacement/renovation, install a Signet Magmeter on each pool recirculation system for accurate flow readings.

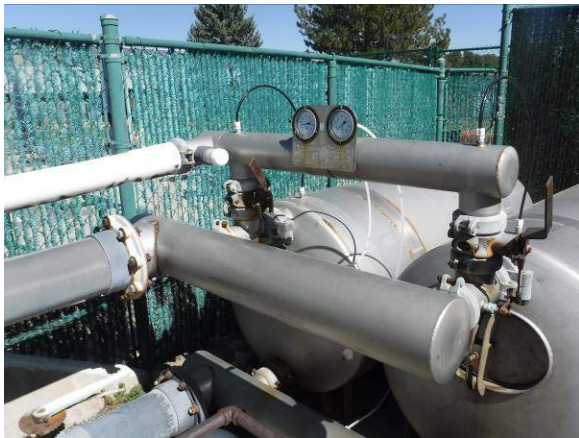
Tanks are anchored on a concrete pad and have influent/effluent gauges, consistent with current aquatic industry standards.

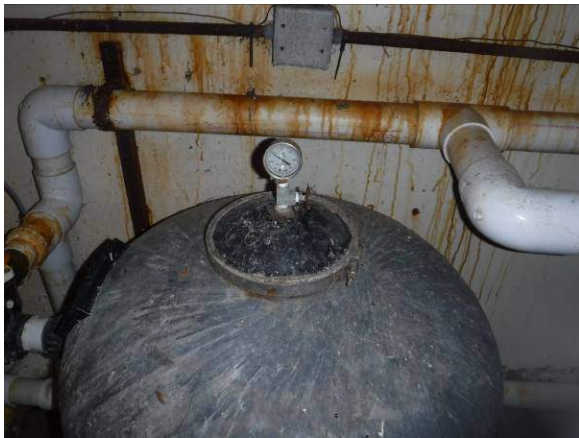
Currently, the wading pool system backwashes and drains to a retention tank in the lower level mechanical area, which routes to storm. This is not allowed by local codes and should be routed to sanitary. Additionally, a 6" air gap between the filter backwash line and the receiving retention tank is required by code.

Alternatively (with any major pool replacement/renovation) consult with civil and plumbing engineers to route a new underground line to the closest sanitary main and include a concrete catch basin for receiving backwash and pool drainage water. Ensure that a 6" air gap is maintained for all filter backwash piping.

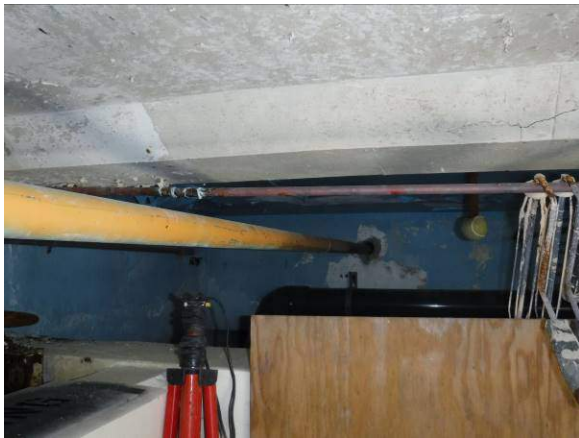
Make-up water is manually added to the wading pool by a hose that is located on the pool deck.

In conjunction with a major pool replacement, provide water level control systems for both pools. An automatic makeup water system is required by Model Aquatic Health Code (MAHC) for the lap pool. However, installation of a system is recommended for both pools. This includes solenoid valves, sensors, and water level controller for each body of water. Lap Pool make-up water could be supplied within the surge tank, and make-up water for the Wading Pool could be supplied via direct fill on the suction side of the recirculation pump with an approved backflow prevention device.

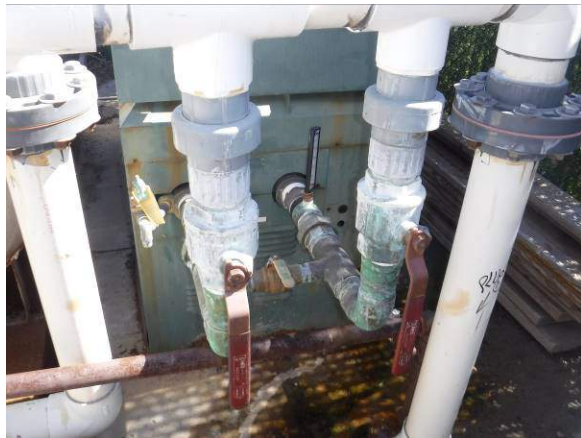
Influent and effluent heater lines are a Schedule 40 PVC material, and the water connections have some staining present.

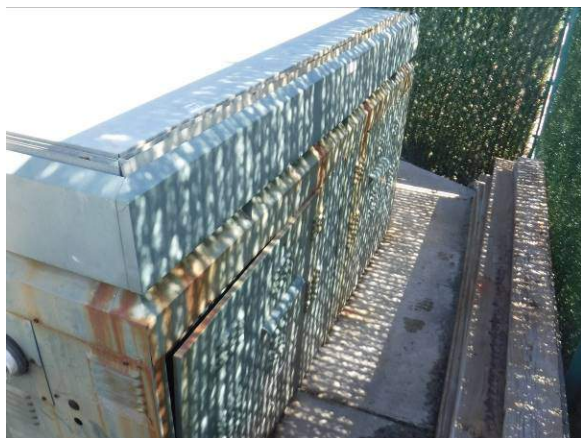
The heater is supported on a cinderblock and is not properly anchored. An emergency stop is provided for the heater in order to comply IECC C404.9.
