# BOULDER COUNTRY CLUB

Boulder, Colorado

## Swimming Pool Audit

November 2020

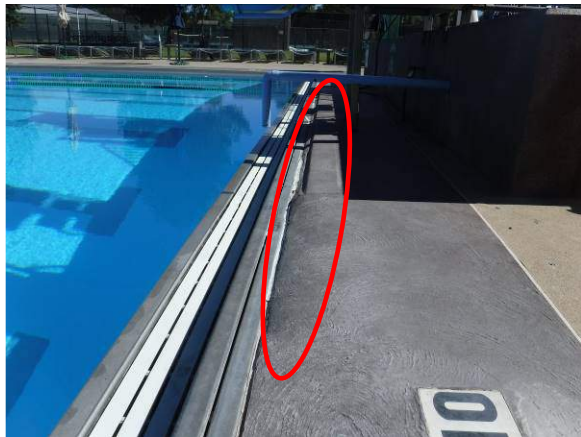
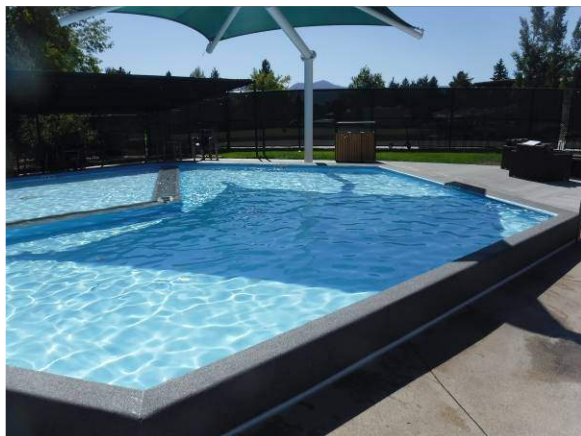
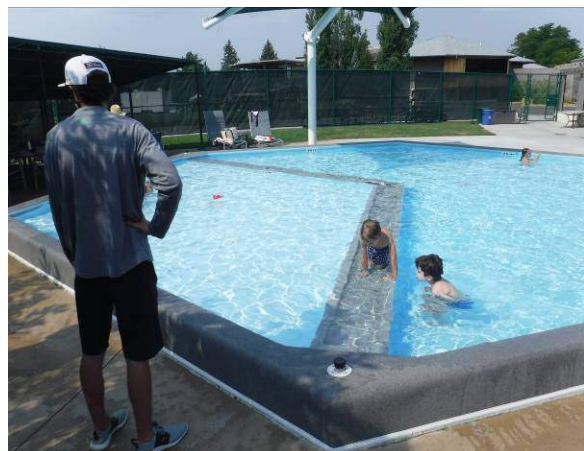
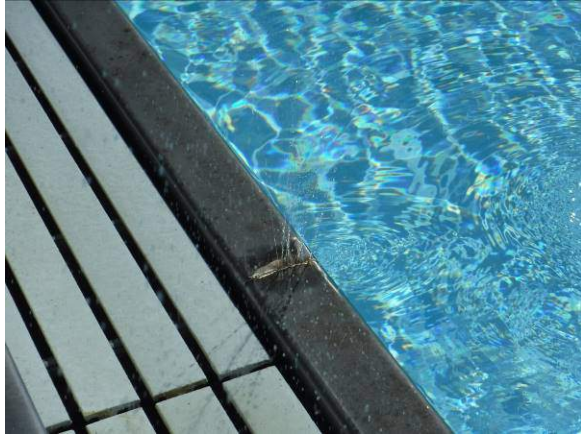
The sealant at the expansion joint of the pool is in fair condition.

Staff has reported that the wading pool concrete structure has been cracking, and the perimeter wall of the pool had crumbled.

A new Renosys PVC liner was installed in the past 2 years and is in good condition. It has not been confirmed whether the wading pool is still experiencing water loss after this installation.

The sealant at the expansion joint of the pool is in fair condition in most locations.

Provide leak detection testing services at the lap pool vessel and the gutter vessel individually. Provide ground penetrating radar testing, Schmidt hammer testing, and core samples in order to determine the condition of the concrete structure. Refer to Appendix A for recommendations regarding leak detection testing and structural testing. Identify any areas where water loss is occurring and repair.

Replace the aging liner at the lap pool.

Perform a water tightness test on the wading pool structure to confirm if water loss is occurring. If it is occurring, how much? Refer to Appendix B for specifications and details regarding a water tightness test.

**In lieu of (or in addition to) all the repairs above, replace the outdoor lap pool and outdoor wading pool structures at the facility. Construct each vessel in accordance American Concrete Institute (ACI) 350 standards to ensure water tightness prior to the application of any pool finishes. Provide a proprietary quartz aggregate finish at all the pools.**

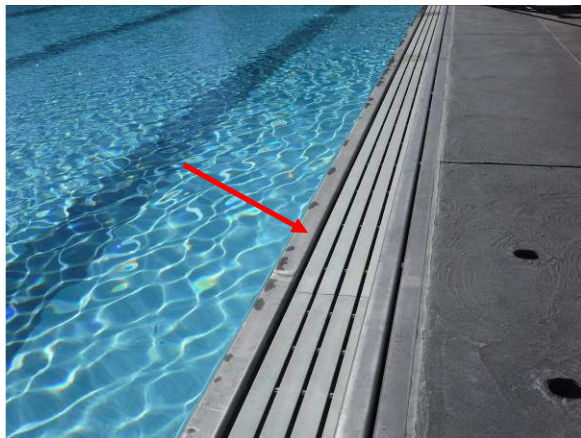
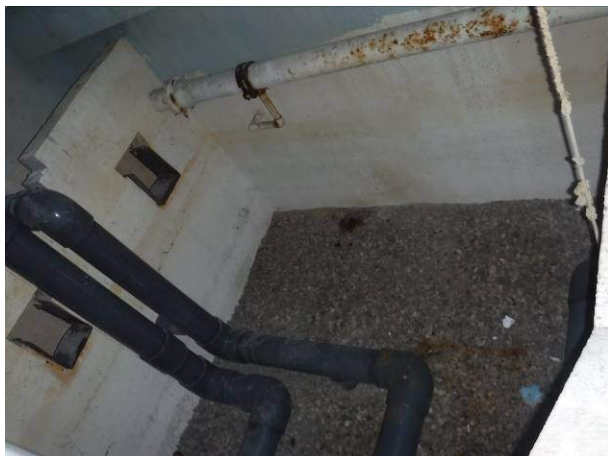
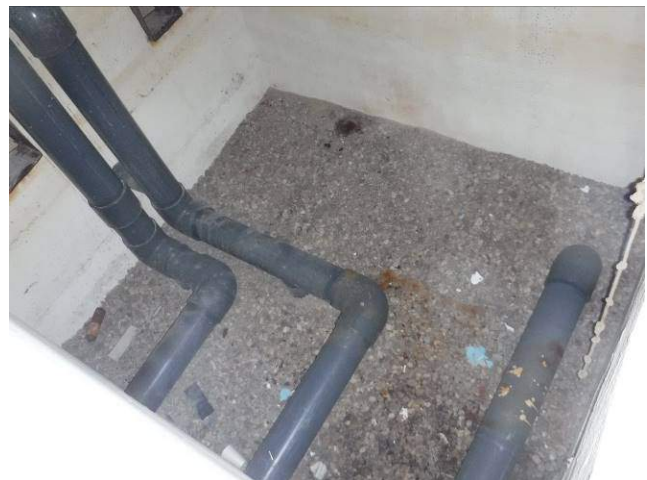
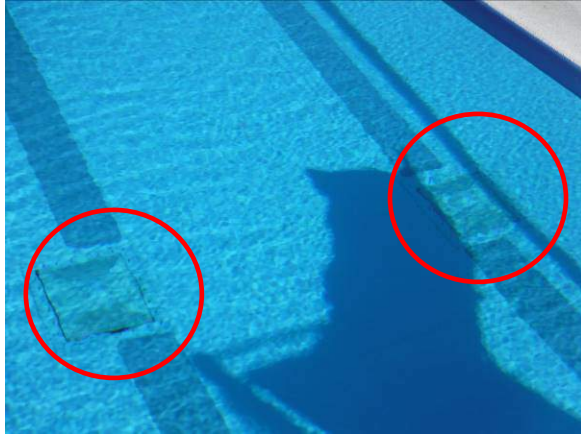
A stainless steel, rollout-style overflow gutter was added to the lap pool in 2003. The gutter has an integrated pressure tube for water return to the pool, and an integrated perimeter deck drain feature at the interface between the pool and the deck. The stainless-steel gutter is in poor condition and it is compromised structurally.

Fiberglass gutter grating appeared to be properly fastened and in fair condition; staff reports that this grating was replaced in 2018.

A surge tank was observed for the lap pool in the space between the mechanical room and the deep end. However, it is not in operation, and float valves are not present. A surge tank is crucial to making sure water level stays consistent in a gutter pool when bathers enter or exit.

Weld and repair the compromised areas of the stainless steel gutter pressure tube system.

In conjunction with a pool replacement, replace the perimeter overflow system in its entirety at both pools.

In conjunction with a pool replacement, provide a surge tank and float valves for any pool system that is utilizing a perimeter overflow gutter rather than skimmers.

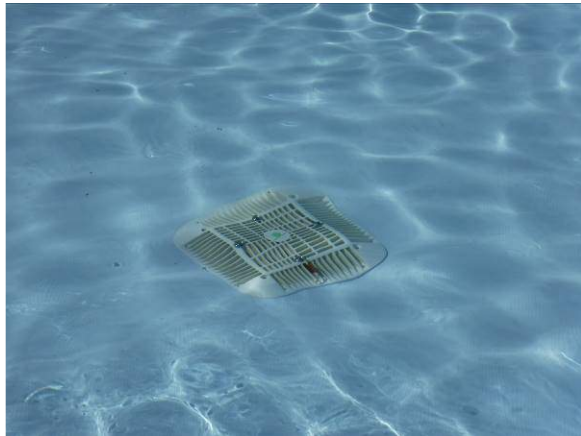
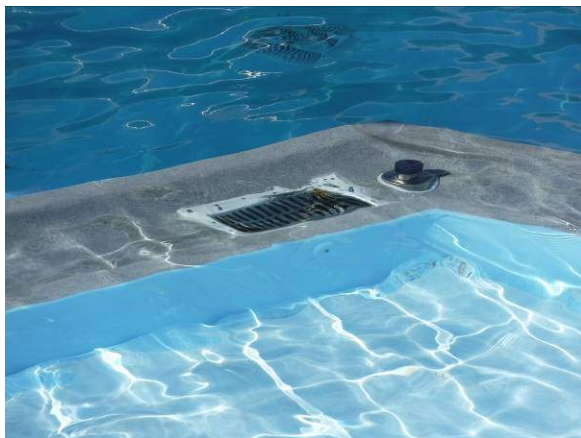
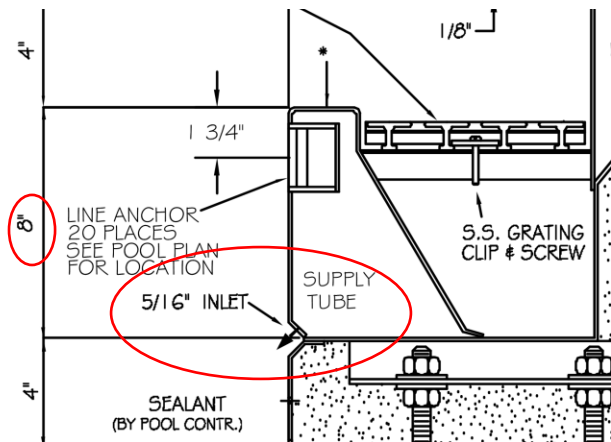
The grates are rated for a maximum flow of 816 gpm, which is greater than the 722 gpm flow rate of the pool. The grates in this pool were last replaced in October of 2018, which indicates these grates are not expired.

At the time of the visit, it could not be confirmed that the hydrostatic relief valves located within the sumps are operational – staff to confirm.

The pool floor drains are Aquastar Grates, model 914xxx. They were recently replaced in 2019 and do not expire anytime soon. With an overall flow rate of approximately 108gpm in the pool, these grates are acceptable.

Confirm that existing hydrostatic relief valves are in-place and operational.

Disconnect piping to the wing wall suction outlet in the wading pool, or plug the suction outlet entirely.

**In conjunction with a major pool replacement, provide prefabricated sumps and piping outlets that are certified as VGB compliant.**

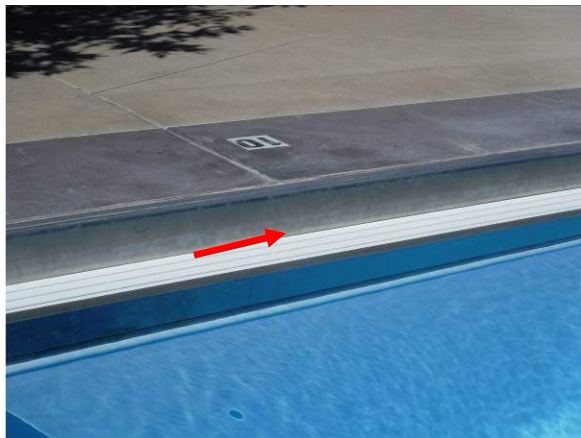
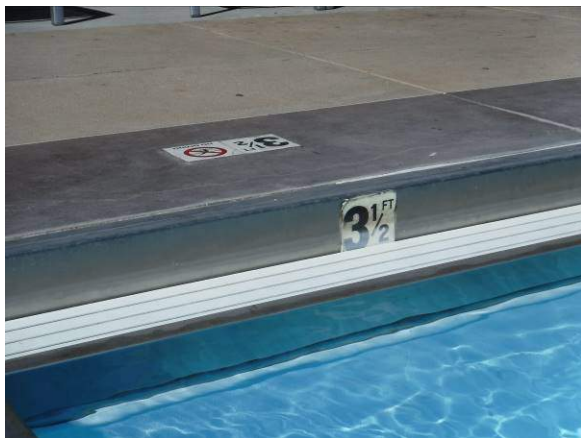
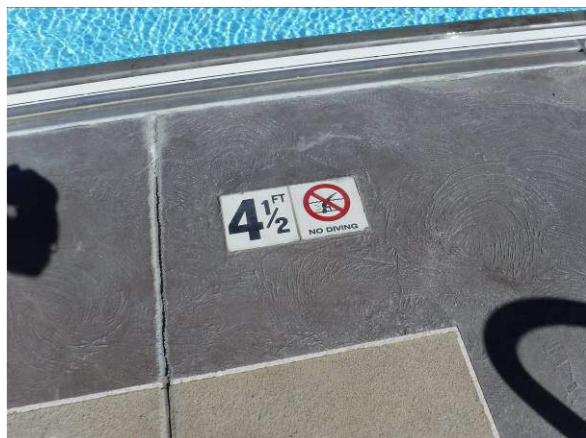
Depth markers and “No Diving” signs were observed around the pool perimeter. Markers are located at the deepest and shallowest point of the pool per code, and on all sides of the pool. There are 20 depth marker locations spread about the 364’ of pool perimeter. This comes out to an interval of a depth marker for every 18’, which meets administrative code.

However, depth markers are not located at the slope break to the deep end as required by MAHC. Some depth markers are only present on the deck and not on the vertical wall of the pool, which violates code. All of the markers do not have “FT” and “IN” designations in 4” height as required by MAHC; and text for the “No Diving” signage must be 4” in height as well. “No Diving” signage must be provided with all depth markers (vertical and horizontal) for all pool depths 5’ and shallower.

The pool does not include a contrasting 4” band at the 5’ water depth moving towards the deep end, and cup anchors are not supplied for a safety rope which is required by administrative code. Contrasting floor markers and wall targets for lap swimming were installed in 2013 according to staff. They are discoloring, and some are beginning to peel away from the pool liner.

Add a 4” width contrasting band at the 5’ water depth drop-off at the lap pool. Provide a safety rope with this contrasting band.

Replace floor markers and wall targets for competitive swimming.

Add or modify depth markers and “No Diving” signage to meet all applicable codes.

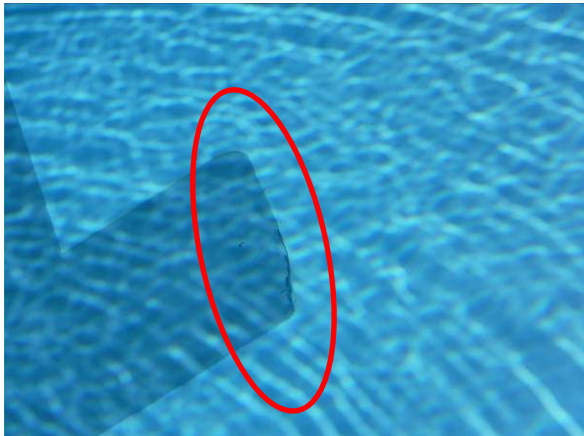
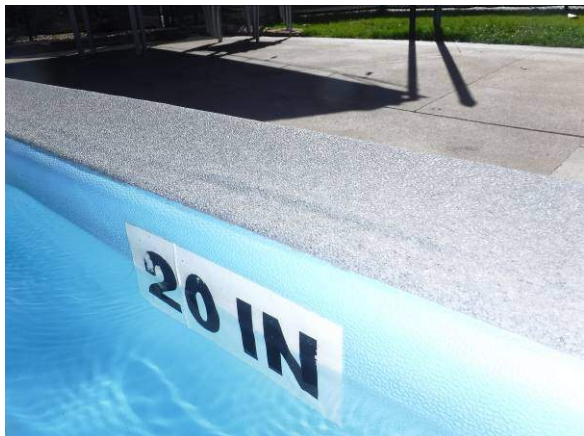
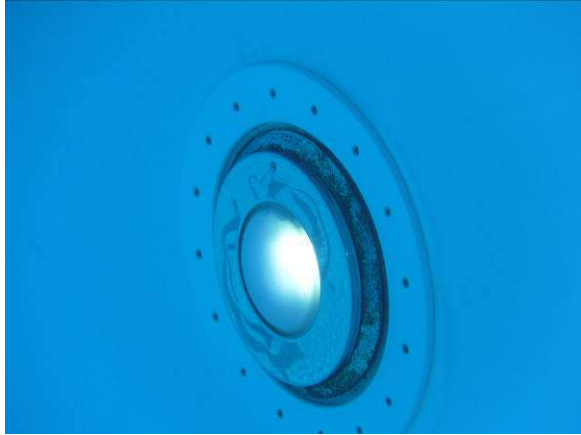
“No Diving” signage was not observed on the horizontal or vertical perimeter faces of the wading pool as required by administrative code. Depth markers are located on the vertical walls of each side of the pool with 4” number/letter heights in accordance with all applicable codes. However, horizontal depth markers are not provided on the perimeter wall of the wading pool as required by code.

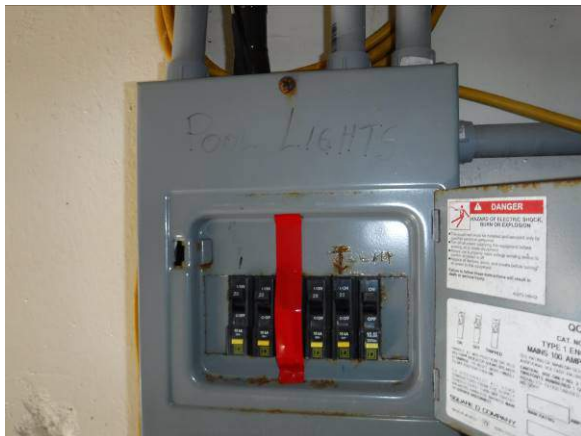
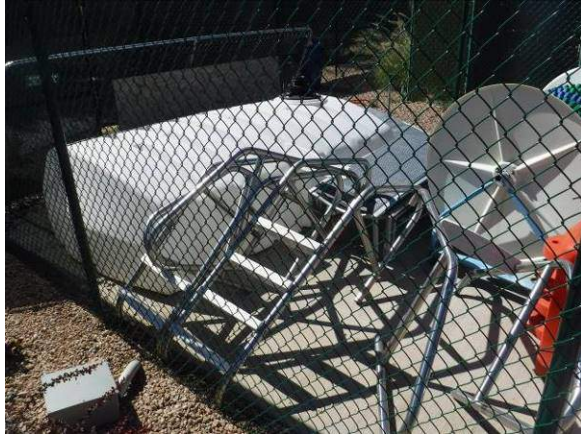
Underwater lights were installed at the lap pool in 2003. There are a total of twelve (12) lights and niches, connecting to six (6) junction boxes that are spread throughout the pool area. These junction boxes are tied to electrical outlets around the pool deck. Four (4) of the lights are not operational: two (2) on the shallow western wall, and two (2) on the deep western wall. Staff has not attempted to replace the bulbs.

With the help of a licensed/certified electrician, check for continuity in the circuit dedicated to the underwater lights. Once proper bonding and continuity are confirmed, replace the underwater light fixtures and their associated wiring. Staff to confirm that all underwater light circuits are GFCI protected.

**In conjunction with a major pool replacement or renovation, provide adequate underwater lighting to meet Model Aquatic Health Code requirements.**

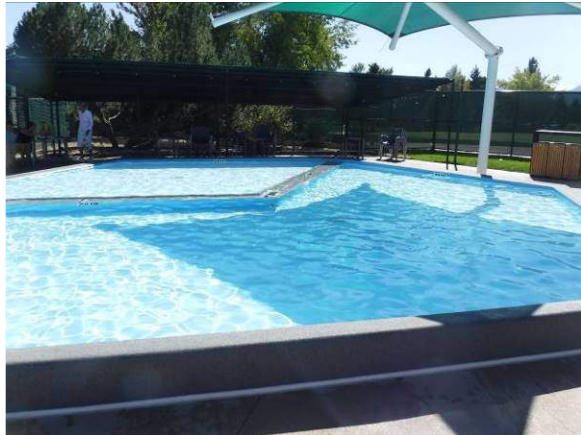
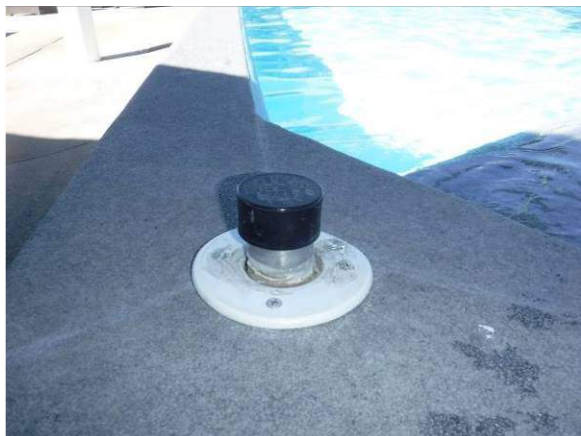
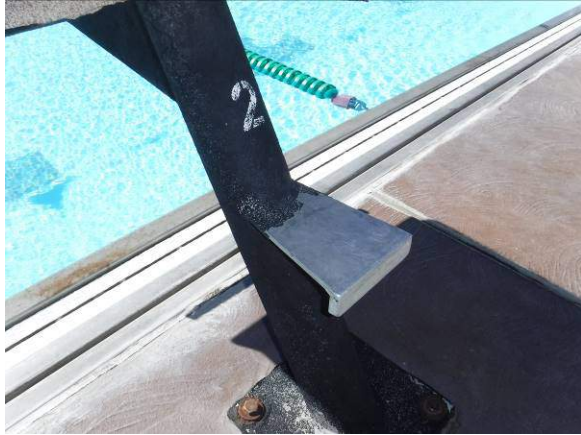
Stainless steel removable ladders were observed in a storage area adjacent to the pool deck, and they appear to be in good/fair condition. Wedge anchors for ladders are installed in the deck and appear to be in fair condition. However, some anchors were missing tightening hardware, or hardware adjustment is prevented by the deck finish. Stanchions for backstroke flags are present, and appear to be in good condition.

Remove the capped guard railings and associated anchors from the wading pool.

**In conjunction with a major replacement, construct a wading pool that includes a zero-depth entry for ADA compliance, and provide necessary ingress/egress as required by code at the lap pool.**

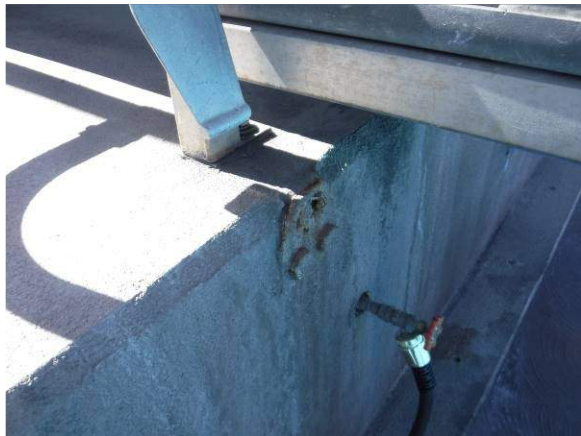
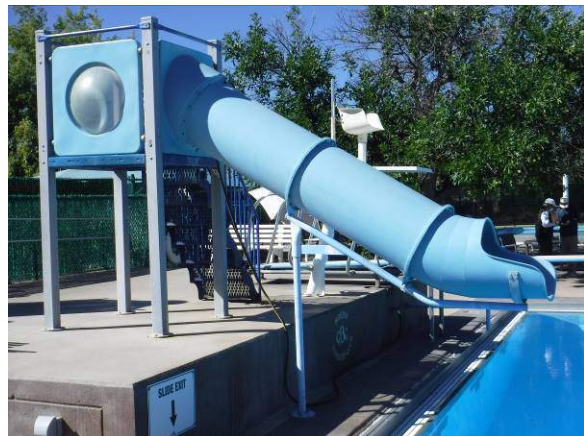
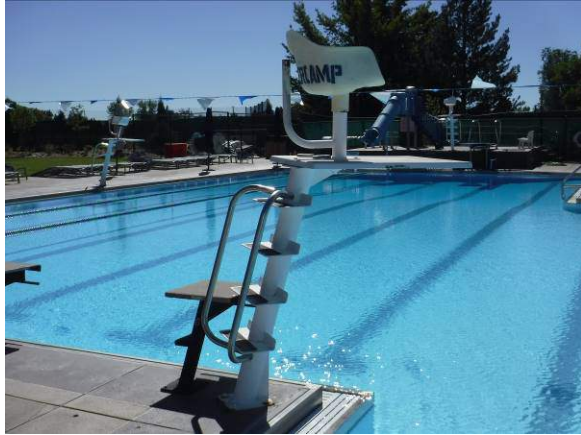
There is a diving board and a drop slide located in the deep end of the lap pool. The dive stand is custom fabricated and is in fair/poor condition. There are signs of staining, and portions of what appears to be a cast-in-place anchor are protruding through the slab face. The board itself appears to be an SR Smith board. Portions of the top are delaminating to a smooth surface, which can be a hazard to divers.

Remove the diving board and close off the dive stand until depths are compliant with administrative code.

**In conjunction with pool replacement, replace the dive stand with a commercial-grade dive stand and spring board (Duraflex) and replace the drop slide structure.**

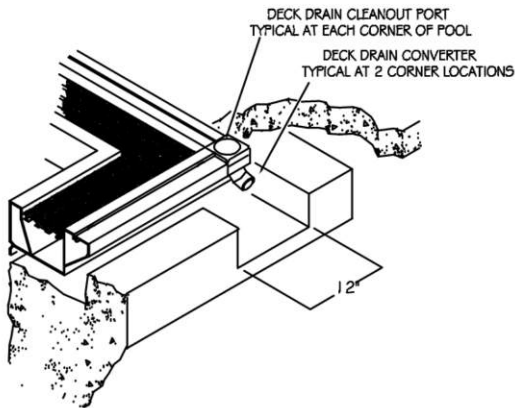
Deck space exceeds the minimum requirements around the entirety of the pool except for the deep end which does not meet MAHC perimeter deck requirements. All decks include a slip resistant finish in accordance with administrative code, but some select areas are beginning to lose slip-resistance.

**In conjunction with a pool deck replacement or a major pool replacement/renovation, request that the Architect and Civil Engineer install a standalone trench drain system rated for commercial pool-use around the perimeter deck.**

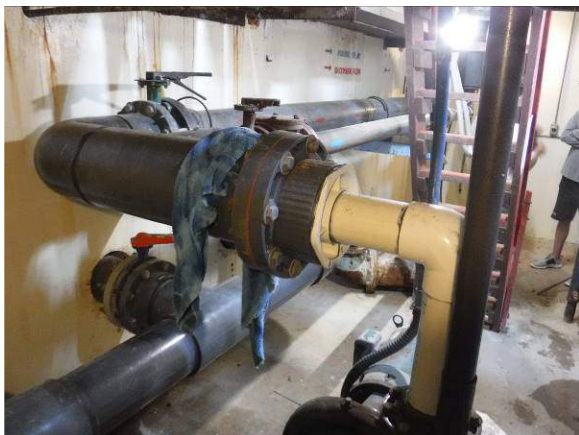
A mixture of Schedule 40 and Schedule 80 PVC piping is supplied for the lap pool recirculation system. It could not be verified whether the existing main drain piping below the pool floor is a cast iron material, or if it was replaced with PVC during main drain sump modifications in 2003. Staff to confirm. Current aquatic industry standard calls for all exposed mechanical room piping to be made of PVC Schedule 80 material.

Supports for all the lap pool piping are in poor condition. Serious signs of corrosion are present, and the piping is not properly supported at appropriate intervals.

The piping does not include flow arrow indicators, and some piping does not include proper color coding as described by administrative code. Metallic hardware is corroding.

Various piping is undersized and exceeds the maximum velocity requirements set forth by code. This piping includes: the filter backwash line, supply line back to the pool inlets, gutter drain converter lines, and pump discharge piping. A set of unnecessary 4" pressure piping is provided on the discharge side of the pump. In some areas there are erratic fittings or changes in pipe sizes.

All metallic valves show signs of corrosion. Valves are not tagged and labeled per MAHC.

Replace all pool piping, fittings, and valves with Schedule 80 PVC material. Ensure that all piping is properly supported with epoxy-coated galvanized steel supports and labeled with color-coded directional flow arrows. Remove all unnecessary piping.

Provide tags for all valves in accordance with MAHC. In conjunction with a major pool replacement/renovation, install a Signet Magmeter on each pool recirculation system for accurate flow readings.

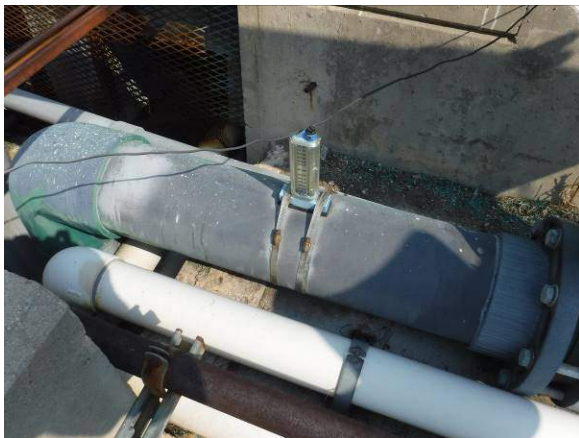
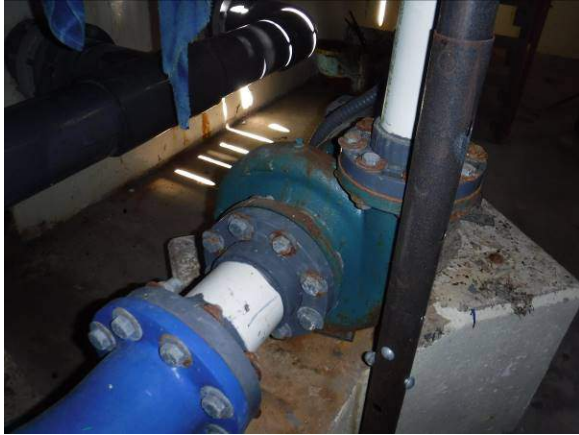
The majority of the wading pool piping is made of a PVC Schedule 40 material. Aquatics industry standard is for all piping to be made of a PVC Schedule 80 material.

Severe corrosion is present for the wading pool piping supports, and supports are not located at appropriate intervals to properly support the pool piping.

Valves appear to be in fair condition, but they are not tagged as required by MAHC.

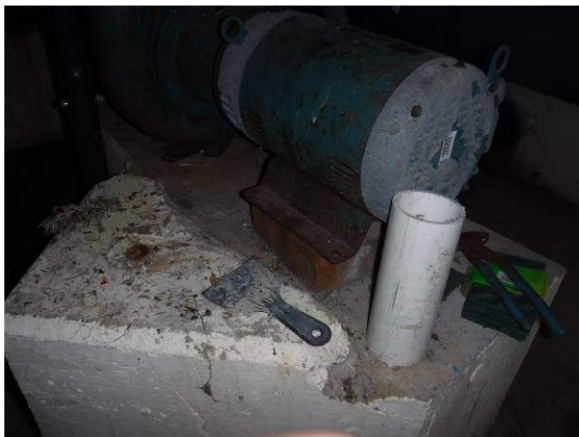
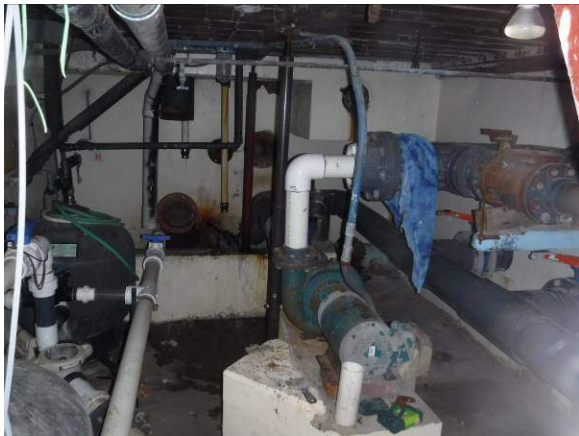
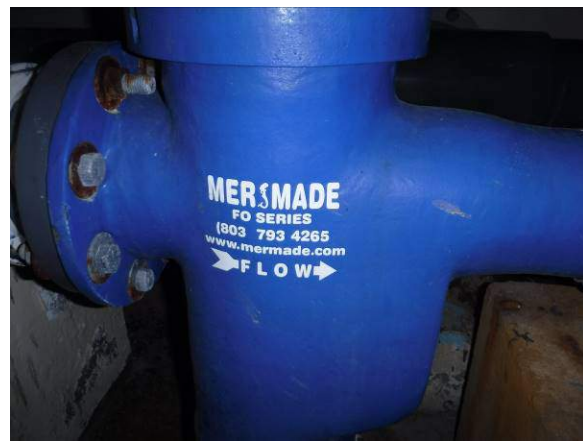
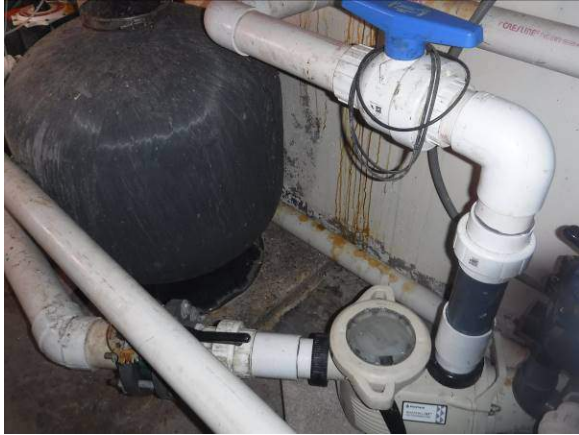
The lap pool recirculation pump is a Marlow Series 530SC pump, with a Baldor 15 HP 1760 RPM motor. The pump was installed in 2014 and appears to be in fair operating condition. There are large amounts of staining and corrosion on the exterior of both the pump and the motor. Both the pump and motor are not properly anchored to the housekeeping pad that is provided.

A compound gauge is not installed on the pump intake port and a pressure gauge is not installed on the pump discharge as required by administrative code. A MerMade reducing strainer is installed on the suction side of the pump and is in fair condition. On the discharge side of the pump, a reducer fitting is not provided to increase pipe sizing per aquatic industry standards.

According to shop drawings provided by staff, a flow rate of 722 gpm is provided by the lap pool pump. This equates to a turnover of approximately 5.64 hours, which meets the administrative code requirement of 6 hours.

A Variable Frequency Drive (VFD) is not provided for the pump per aquatic industry standards. Staff to confirm that the motor is properly bonded with the pool in accordance with NEC Article 680.

**In conjunction with a major pool replacement/renovation, install a VFD with every pool to save energy and maintain a more consistent system flow rate.**

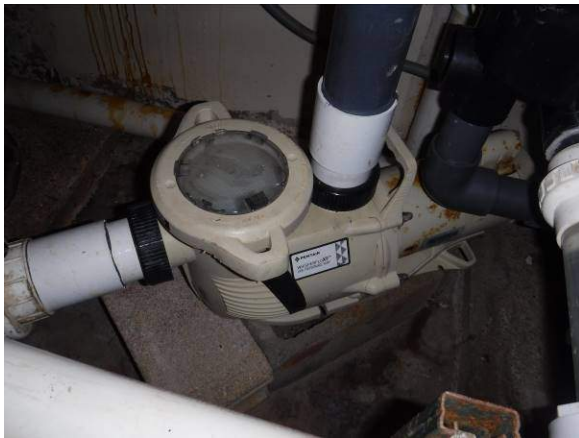
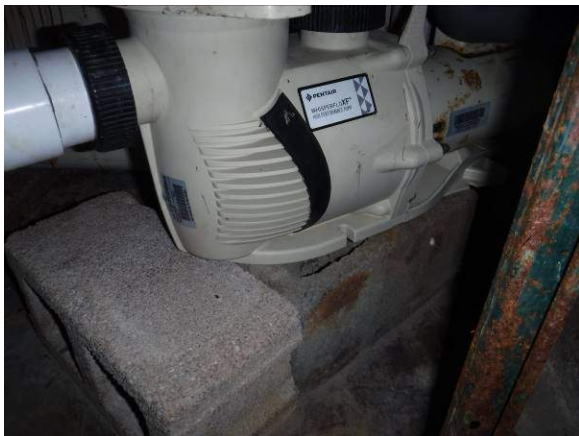
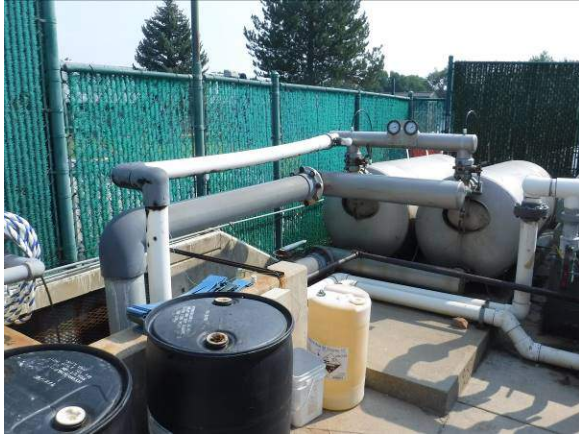
A Pentair Whisperflo XFE-12 3 HP pump/motor is provided for the wading pool. This pump was installed in 2015 and appears to be in fair condition aside from some surface staining and chipping. The pump is not properly anchored on a housekeeping pad per aquatic industry standard.

Increase the flow rate through the wading pool recirculation pump to a minimum of 146 gpm. If flow cannot be increased to meet a turnover of 1 hour, replace the pump.

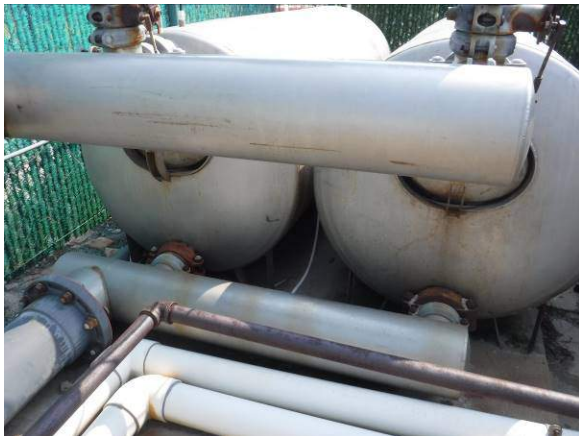
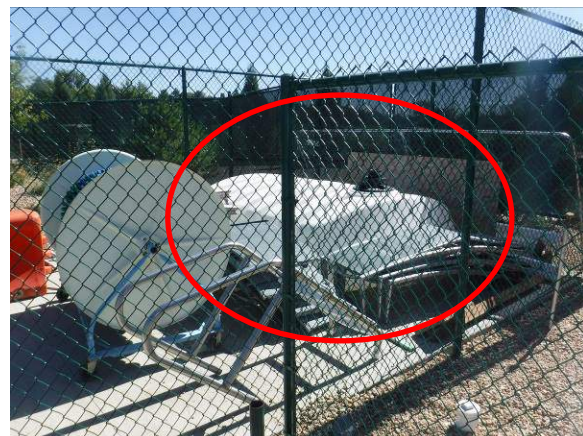
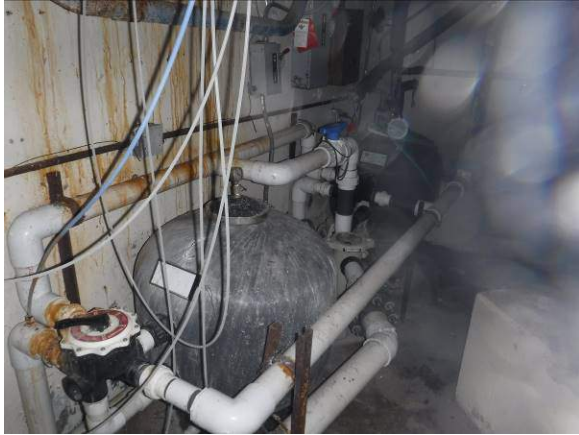
Currently, the lap pool system backwashes and drains to a retention tank in the lower level mechanical area, which routes to storm. This is not allowed by local codes and should be routed to sanitary. A retention tank was purchased for addressing this issue, and it can be seen in the pool storage area. The tank and the required sump pump have not been installed at this time. Additionally, a 6" air gap between the filter backwash line and the receiving retention tank is required by code.

Install the in-ground backwash retention tank and use a sump pump to route backwash water to sanitary.

Alternatively (with any major pool replacement/renovation) consult with civil and plumbing engineers to route a new underground line to the closest sanitary main and include a concrete catch basin for receiving backwash and pool drainage water. Ensure that a 6" air gap is maintained for all filter backwash piping.

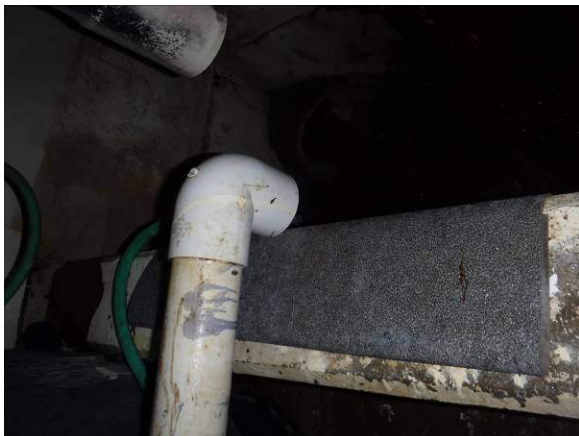
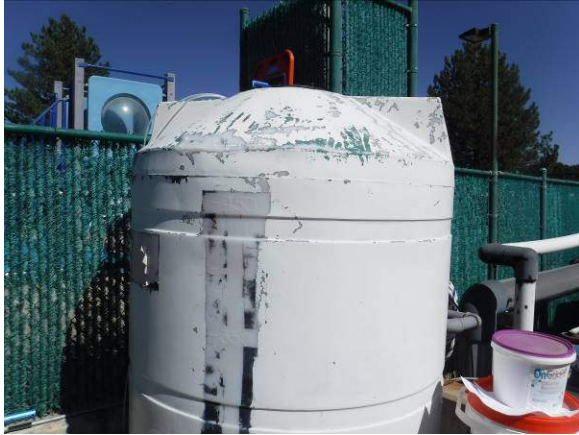
Two (2) small Baker Hydro HRV-30 sand filtration tanks are installed in the lower level mechanical room for use with the wading pool system. These NSF-approved tanks were installed in 2016 and appear to be in fair condition aside from some staining.

Replace the lap pool HydroKleen filters with a new set of horizontal high rate sand filter tanks. These tanks should be manufactured by Neptune-Benson, Paragon/Stark, or Waterco. The tanks should also include linkage PVC Sch 80 face piping, automatic air relief, name plate, and influent/effluent gauges.

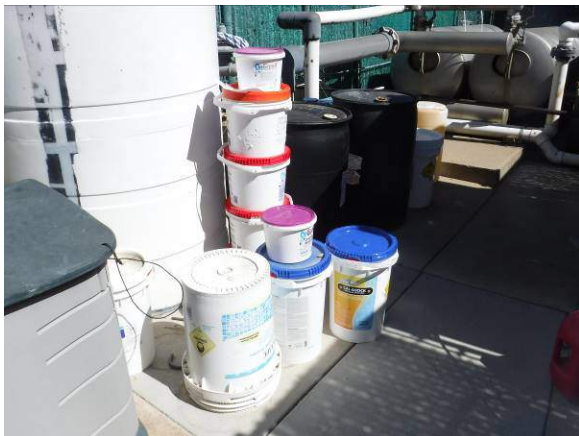
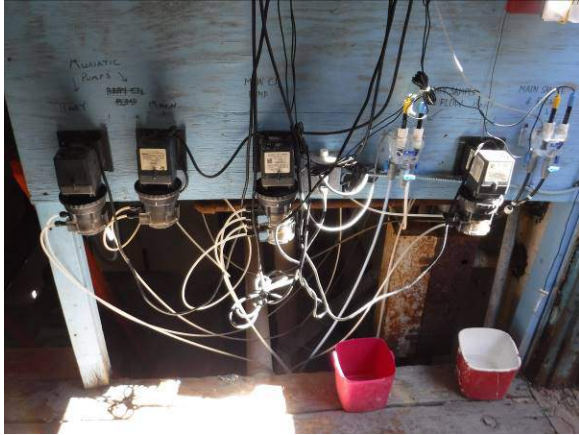
Stenner peristaltic feed pumps are used to supply chemicals into the lap pool system. These chemical feed pumps are properly sized and appear to be in good condition. Chemicals are routed to/from the feed pumps with translucent poly tubing, and they are fed into the recirculation system downstream of the filters, heaters, and chemical controllers as required by code. However, the poly tubing is not secured within Schedule 80 PVC piping to prevent any accidental damage or leaks in the lines, as recommended by current industry standards.

A Polaris WaterMatic C660 chemistry controller is used to maintain water chemistry in the lap pool. The chemistry controller is aging but appears to be in good working order. Staff has reported that probes are cleaned on a regular basis to maintain accuracy. Flow cells are transparent and have a sample spigot as recommended by current industry standard.

Encase all poly feed tubing in Schedule 80 PVC Pipe in order to prevent any damage or leaks to the piping.

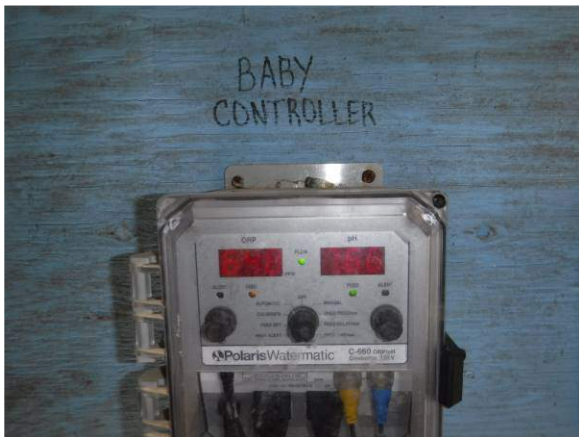
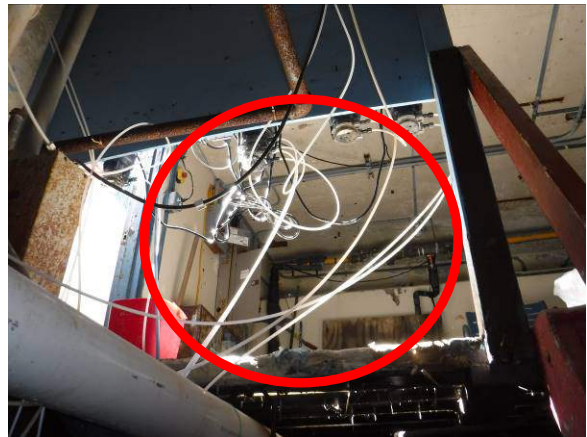
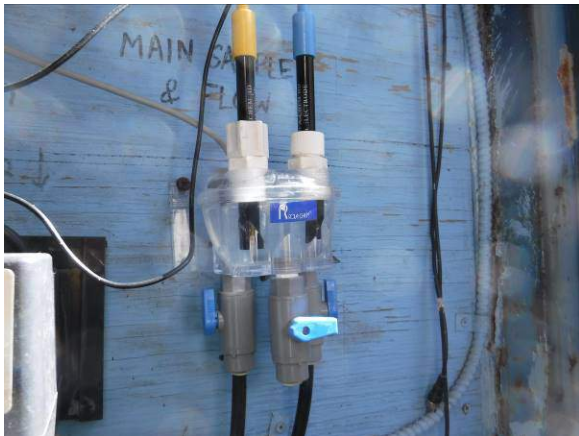
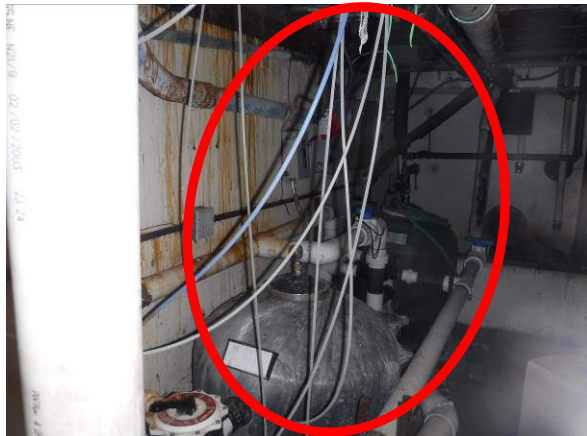
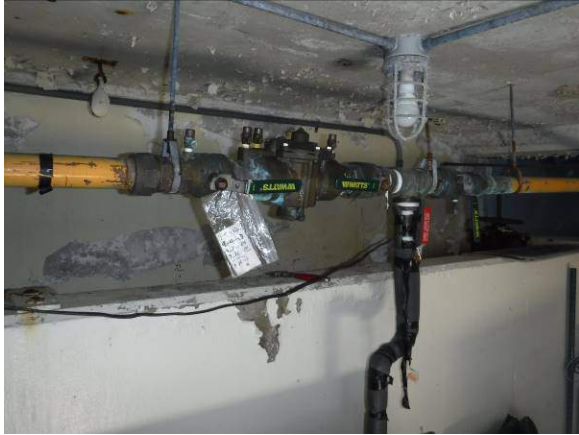
The wading pool uses the same systems and setups for sanitizer feed and pH buffer feed as the lap pool.

However, MAHC requires that any wading pool be equipped with a secondary disinfection system, which was not observed. An example of secondary disinfection is an Ultraviolet System.

In conjunction with any major pool replacement/renovation, provide a UV system for the wading pool. Additionally, provide new chemistry controllers for both pools that have the capability for connection with flow meter sensors and Fireman Cycle features.

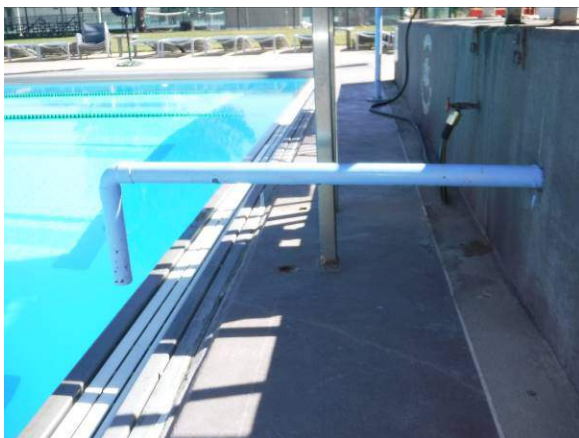
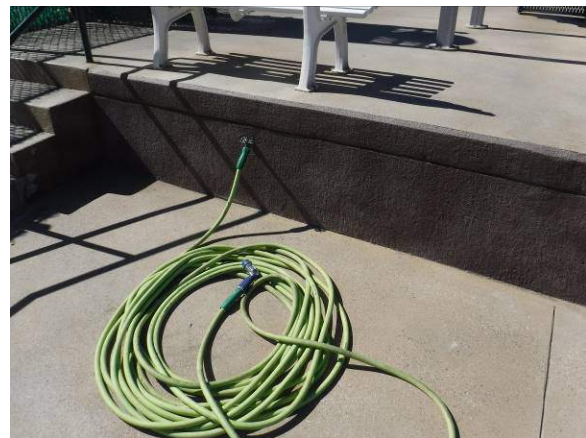
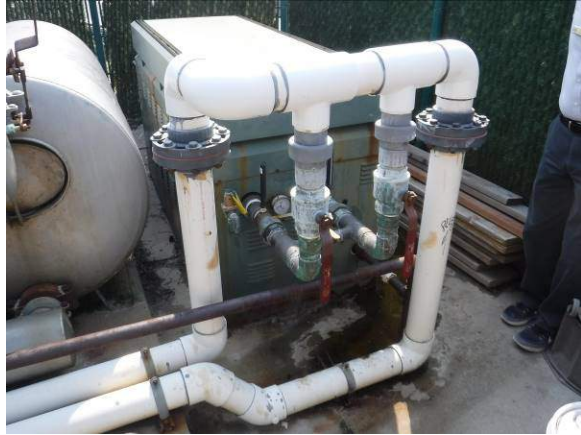
Make up water is manually added to the lap pool via the water supply which can be accessed with valves that are located within the mechanical room space. The water flows and drops into the pool directly underneath the springboard via an air gap, in accordance with administrative code. Valves and piping used for this system show their age and require replacement soon.

In conjunction with a major pool replacement, provide water level control systems for both pools. An automatic makeup water system is required by Model Aquatic Health Code (MAHC) for the lap pool. However, installation of a system is recommended for both pools. This includes solenoid valves, sensors, and water level controller for each body of water. Lap Pool make-up water could be supplied within the surge tank, and make-up water for the Wading Pool could be supplied via direct fill on the suction side of the recirculation pump with an approved backflow prevention device.

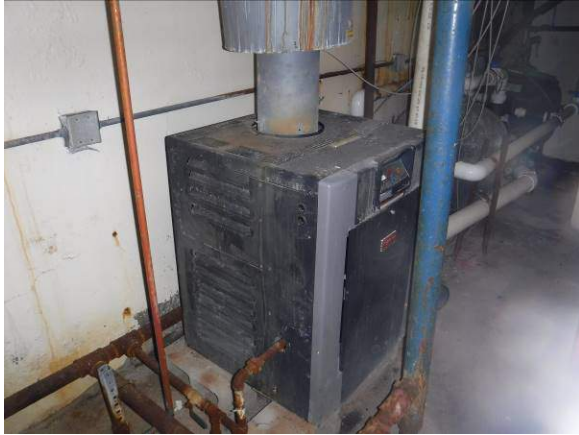
A Raypak 406A High-Altitude pool heater is installed for use with the wading pool system. The heater was installed around 2014 according to staff and appears to be in fair condition aside from some surface staining. Initial calculations indicate that this heater is on the border of slightly undersized to adequately sized – staff indicate that this heater performs much better than its lap pool counterpart.

The gas line supplying for this heater shows signs of aging and corrosion.

The heater is supported on a cinderblock and is not properly anchored. An emergency stop is provided for the heater in order to comply IECC C404.9.

Provide the existing wading pool heater with CPVC influent/effluent piping, new natural gas supply piping, thermometers, and a concrete housekeeping pad for proper anchoring.

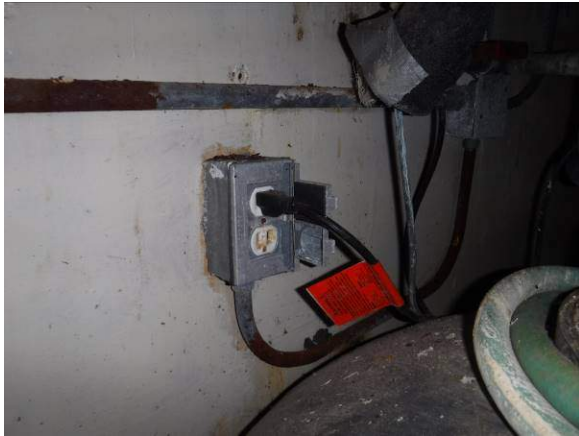
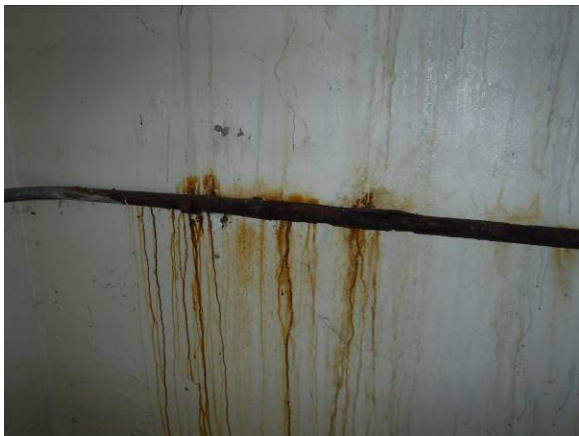
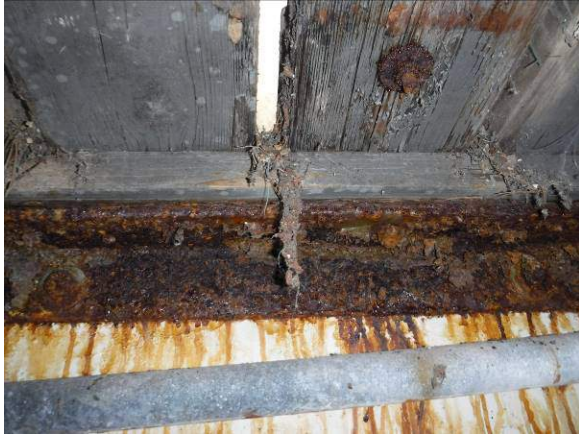
Electrical outlets that are present within the mechanical room do not include GFI protection. Aquatic industry standard calls for all pool mechanical room outlets to be GFI protected.

Several sections of conduit show serious signs of corrosion. Within the mechanical area, there are several exposed wires that are not protected by conduit. Each pool structure, all of its mechanical equipment, and metallic items located within 5' of the pool are required to be bonding in accordance with NEC Article 680. This could not be confirmed at the time of the audit visit.

Replace any corroded conduit and encase any loose wires in or around the mechanical room.

**In conjunction with a major pool replacement/renovation, install all GFI electrical outlets within the mechanical room and out on the pool deck.**

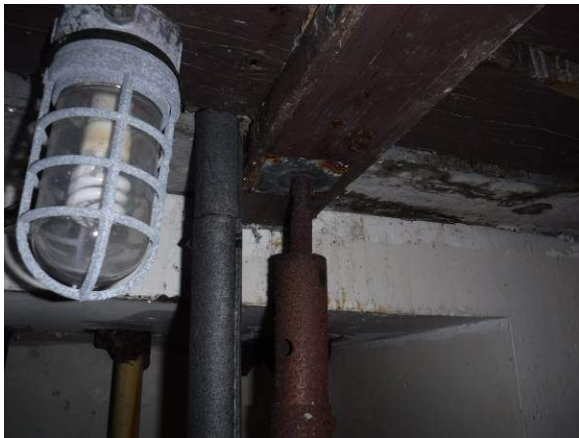
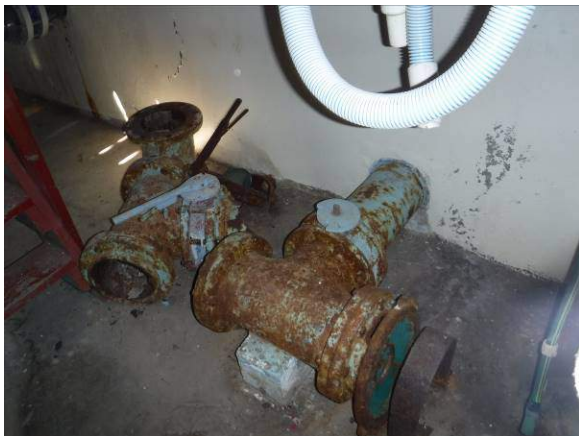
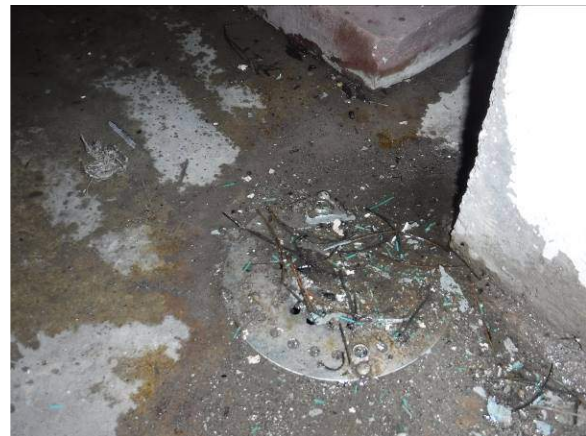
The upper wood decking of the pool mechanical room is currently supported by a combination of severely corroded angle iron and precariously placed column jacks. This poses a serious hazard to all staff and anyone entering the pool mechanical space.

Provide new decking and supports for the upper level mechanical areas to ensure the safety of pool operators.

General cleaning of the mechanical room area is required.

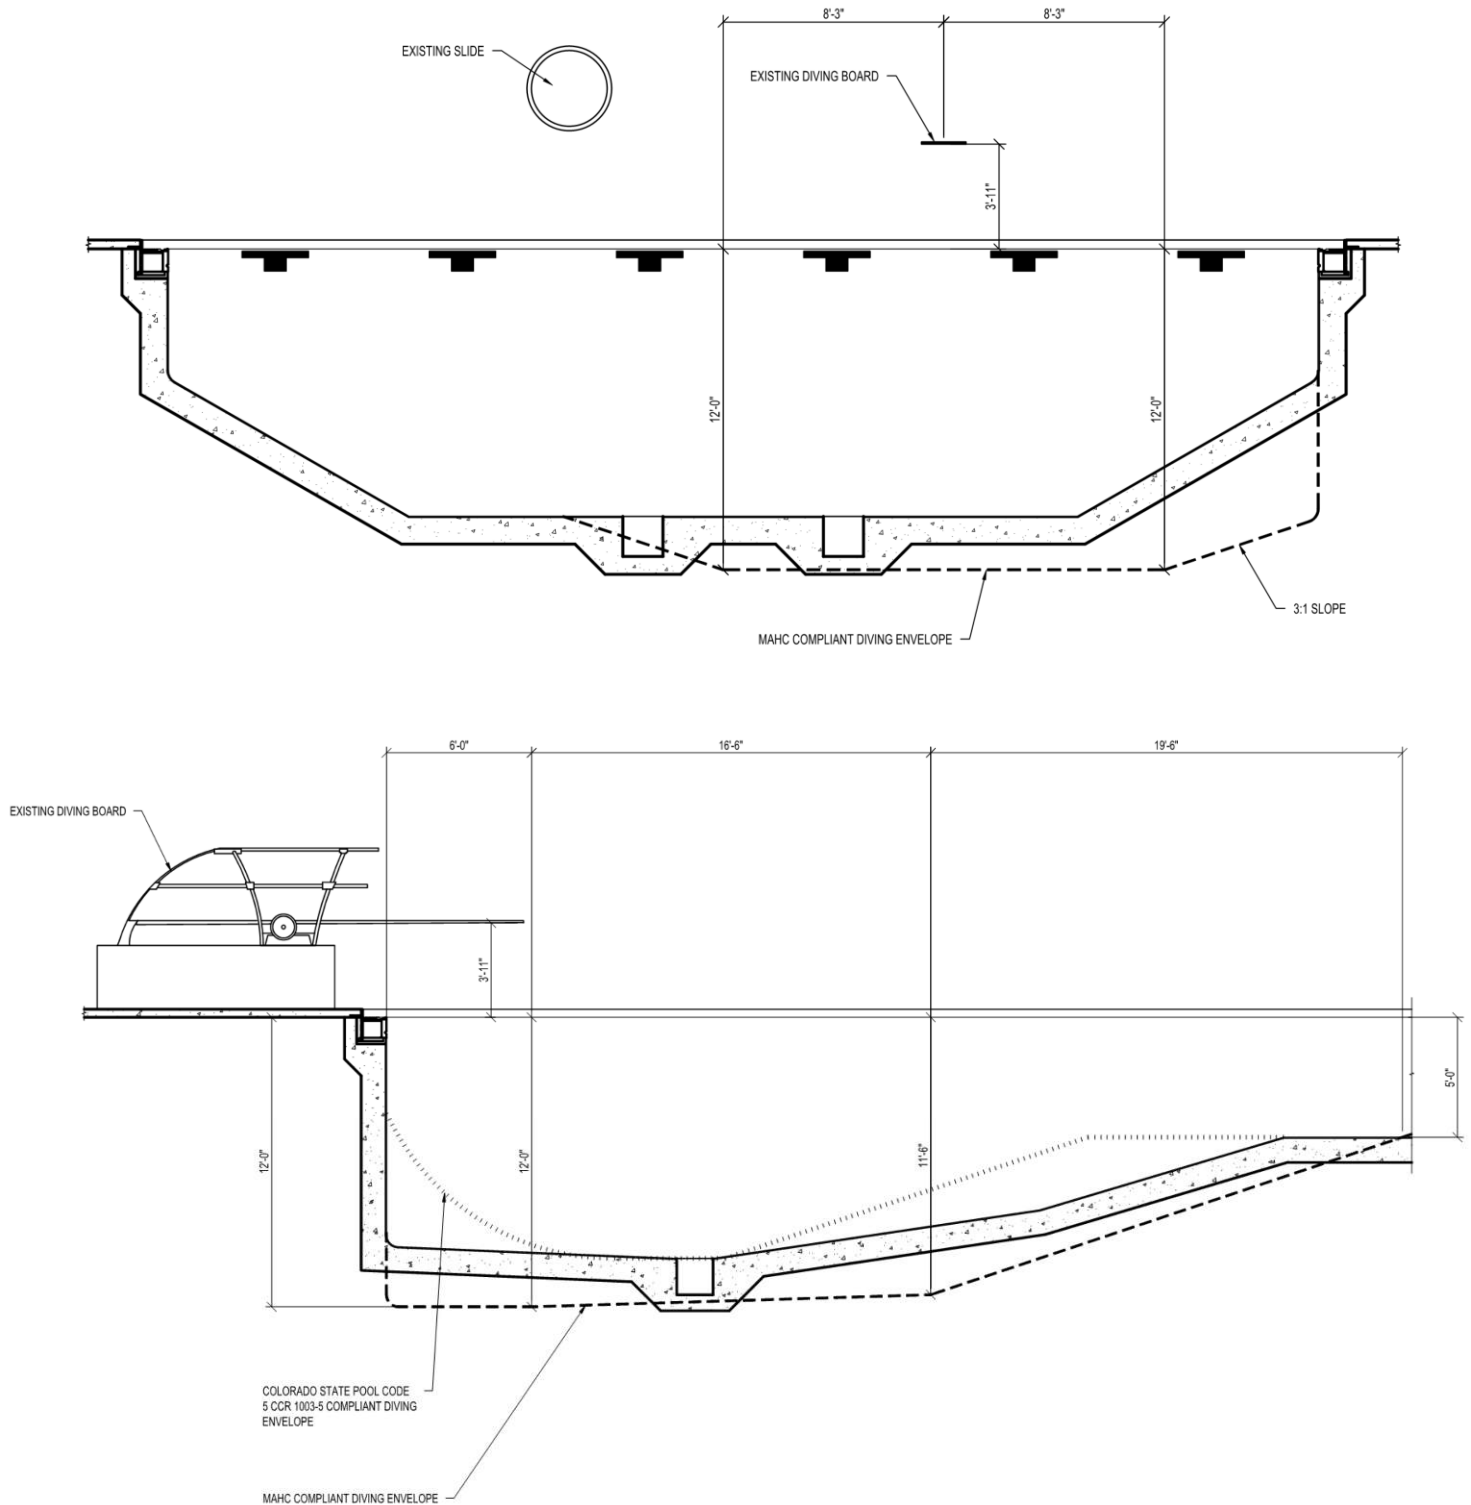
## APPENDIX C: DIVING ENVELOPES – COMPARISON OF CODE MINIMUMS WITH THE EXISTING DIVING WELL DIMENSIONS

**\*\*\*Note that the code profiles shown by dashed and dotted lines reflect a diving board height of one meter. The existing diving board is installed above that height.**
